The Union Pacific Railway bridge over the Guadalupe River near Willow Street caught fire at 3:15 AM Wednesday morning, Nov. 1, 2017. (To see some pretty impressive video of the fire, go to: <http://kron4.com/2017/11/01/video-fire-on-caltrain-bridge-in-san-jose/> .)

~Larry Ames, 11/7/17

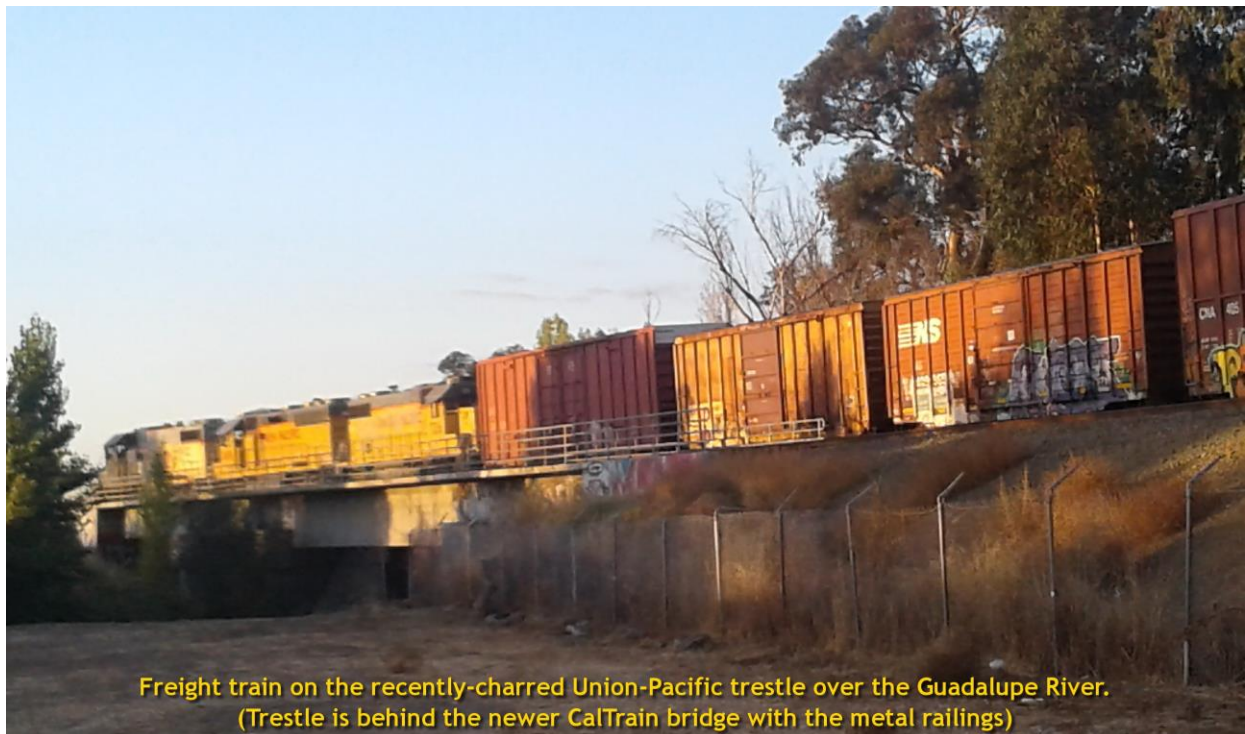
They said that the trestle is fine and suitable for freight trains.

I asked about the criteria, and they said they hit the various posts with a hammer: if the char on the timbers is less than an inch deep, it'll carry the weight.

Recently I got a first-hand view of a freight train crossing the trestle. I only had my cell-phone with me, but nonetheless here is photographic evidence that the trestle was not "consumed" or even significantly damaged by the fire.

Freight train on the recently-charred Union-Pacific trestle over the Guadalupe River.
(Trestle is behind the newer CalTrain bridge with the metal railings)
