Train Bridge Fire

The Union Pacific Railway bridge over the Guadalupe River near Willow Street caught fire at 3:15 AM Wednesday morning, Nov. 1, 2017. (To see some pretty impressive video of the fire, go to: <http://kron4.com/2017/11/01/video-fire-on-caltrain-bridge-in-san-jose/>)

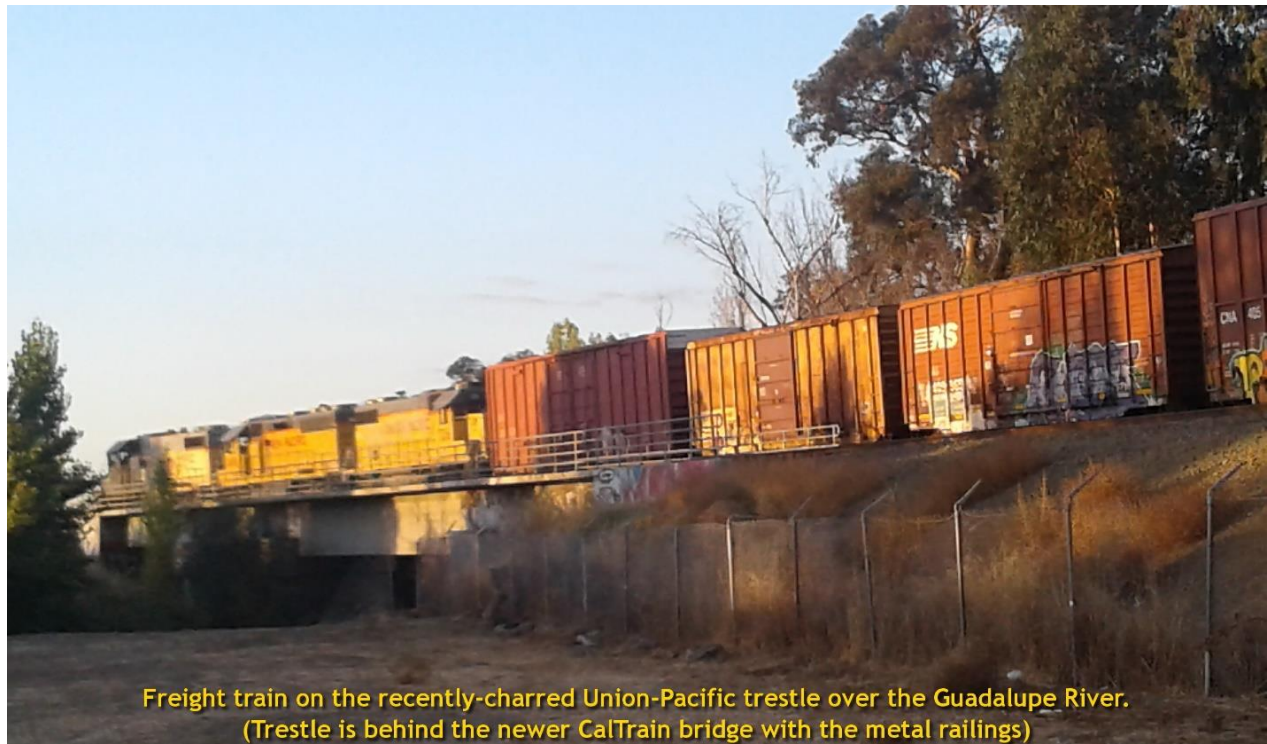
They said that the trestle is fine and suitable for freight trains.

I asked about the criteria, and they said they hit the various posts with a hammer: if the char on the timbers is less than an inch deep, it'll carry the weight.

Recently I got a first-hand view of a freight train crossing the trestle. I only had my cell-phone with me, but nonetheless here is photographic evidence that the trestle was not "consumed" or even significantly damaged by the fire.

Freight train on the recently-charred Union-Pacific trestle over the Guadalupe River.
(Trestle is behind the newer CalTrain bridge with the metal railings)

with a wooden trestle-like “entrance ramp” -- the part that caught on fire. As can be seen in the photo, the train is on that second bridge, as both sets of hand-rails on the foreground bridge are plainly visible.)
